# SUNSONG

### **OE QUALITY BRAKE HOSE ASSEMBLIES**

### VISUAL SIGNS IT'S TIME TO REPLACE BRAKE HOSES

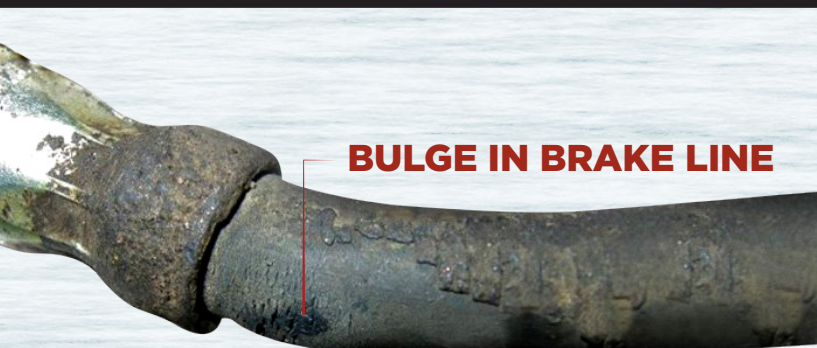
**BULGE IN BRAKE LINE**

1. Rubber hoses can degrade from exposure to the elements like UV rays, salt, road debris and ozone.
2. Brake fluid absorbs water over-time and can rust the inside of the tubing. This may not be visible until a leak develops.
3. Heat and moisture can weaken rubber at points connecting to the line. A crack in the hose inner lining can lead to visible leaking/seepage.

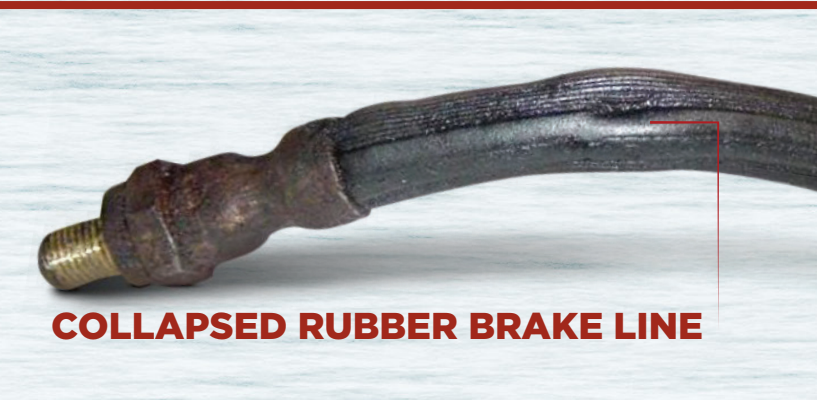
**COLLAPSED RUBBER BRAKE LINE**

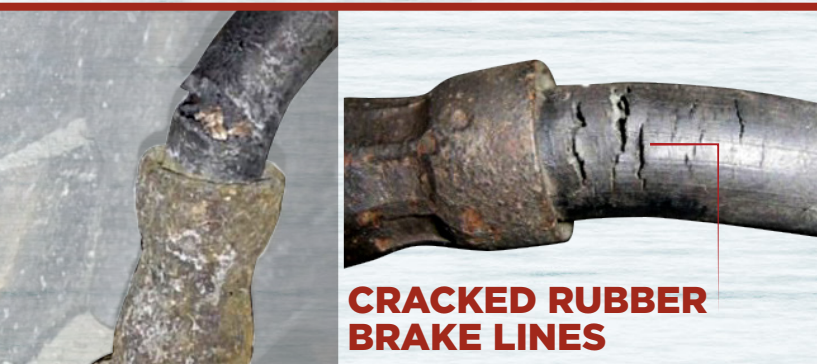
**CRACKED RUBBER BRAKE LINES**
